## SYSTEM FAILURE CASE STUDIES

JANUARY 2011 VOLUME 5 ISSUE 1

# Fire in the Sky

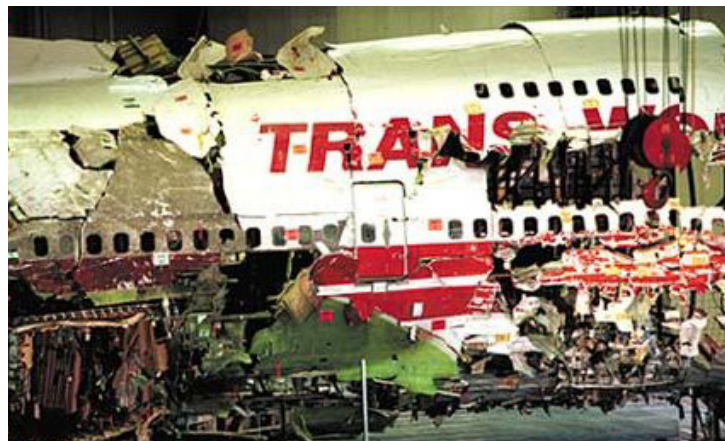
**Figure 1: The reconstructed fuselage of TWA 800**

The widespread distribution of wreckage and eyewitness observations were the first indications that TWA 800 had experienced a sudden and catastrophic in-flight structural failure. It had been airborne for only 12 minutes.

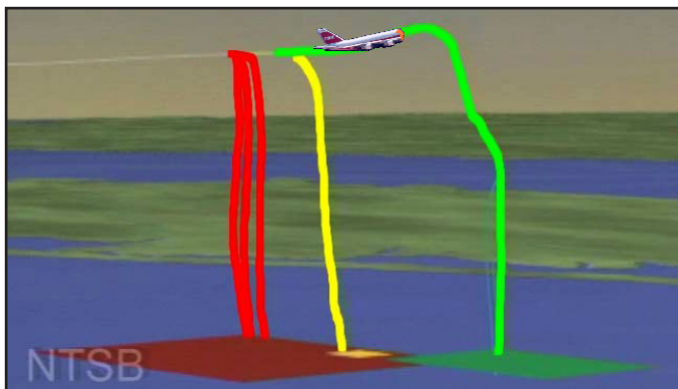
Following a fruitless search for survivors, a ten-month recovery effort by multiple agencies and companies found three debris fields, called red, yellow, and green (Figure 2). Within the first weeks, investigators found initial evidence of an explosive event in a fuel tank. Aircraft, fire, and explosive experts from the NTSB, DoD, FBI, ATF, FAA, and other parties associated with the investigation examined each recovered piece (over 95% of the aircraft) for evidence of bomb, missile or high-order explosive characteristics. They found no such evidence, and 18 months after the crash, the FBI officially terminated its criminal investigation. The safety investigation continued for nearly three more years.

**Figure 2: Red, Yellow, and Green Debris Fields**

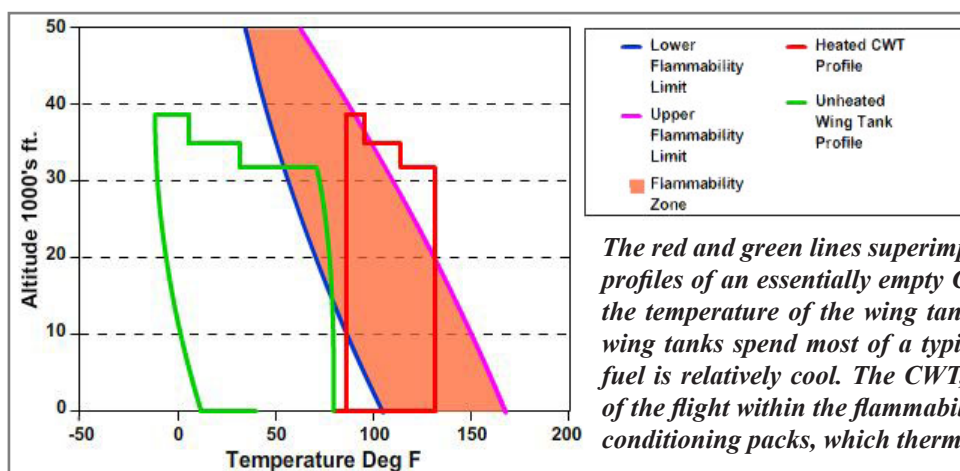
The Boeing 747-100 series uses Jet-A fuel from seven fuel tanks. Each wing contains three tanks. The lower fuselage holds a seventh tank, known as the center wing fuel tank (Figure 4). The CWT has a fuel capacity of 86,363 pounds, but whenever the six wing tanks hold sufficient fuel for a flight, the CWT only contains fuel remaining from the last flight, providing optimal spanwise wing load distribution. Ground crew personnel measured approximately 300 (about 50 gallons) pounds of fuel in the CWT prior to Flight 800's final takeoff. Under such conditions, the CWT ullage – the unfilled portion of the tank above the surface of the fuel – contains a mixture of fuel molecules and air whose combustibility depends upon its fuel-air ratio, temperature, and pressure. The aircraft's three air-conditioning packs, which could radiate heat at up to 350 degrees F, rested in an uninsulated, unvented compartment just inches beneath the CWT's aluminum floor. The tank and ullage absorbed heat from the packs for 2 ½ hours on the ground. Testing found that a near-empty center tank heats quickly, speeding fuel evaporation and increasing the flammability of the ullage. Additionally, increasing altitude as the airplane climbed lowered the air pressure, reducing the temperature needed to ignite the fuel/air mixture. (Figure 3 illustrates the flammability envelope for Jet-A fuel.)

**Figure 3: Flammability envelope for Jet A fuel.** To the left of the blue line, the vapor is too lean to support combustion. To the right of the pink line, the vapor is too rich to support combustion.

*The red and green lines superimposed upon the graph represent hypothetical flight profiles of an essentially empty CWT (red) and 6 full wing tanks (green). Because the temperature of the wing tanks is dictated by the temperature of the fuel, the wing tanks spend most of a typical flight outside the flammability zone since the fuel is relatively cool. The CWT, on the other hand, spends a substantial portion of the flight within the flammability zone. This is due in part to its proximity to air-conditioning packs, which thermally influence the CWT.*

During the course of the NTSB investigation, it became clear that sole reliance upon ignition preventive design was an inadequate means of avoiding a CWT explosion; somehow, the CWT itself had to be rendered incombustible as an additional layer of protection. The military had accomplished this in combat aircraft by using systems to inject inert gas such as nitrogen to displace oxygen in fuel tanks from 21% down to 9%. Such systems had been considered unnecessary in cost and weight by the commercial transport aircraft industry. However, by recognition that commercial airplanes did not need the level of inerting used by the military, the FAA developed a relatively lightweight and simple flammability reduction system (FRS) from advanced inerting system technologies. These developments made retrofitting of commercial aircraft feasible. In 2008, the FAA issued a fuel tank flammability rule requiring airlines to retrofit (within 10 years) a means to reduce the flammability of heated fuel tanks in all Boeing and Airbus aircraft manufactured before 2009. Methods could include systems to displace oxygen in tanks with inert nitrogen, or use of materials to mitigate ignition such as polyurethane foam fill.

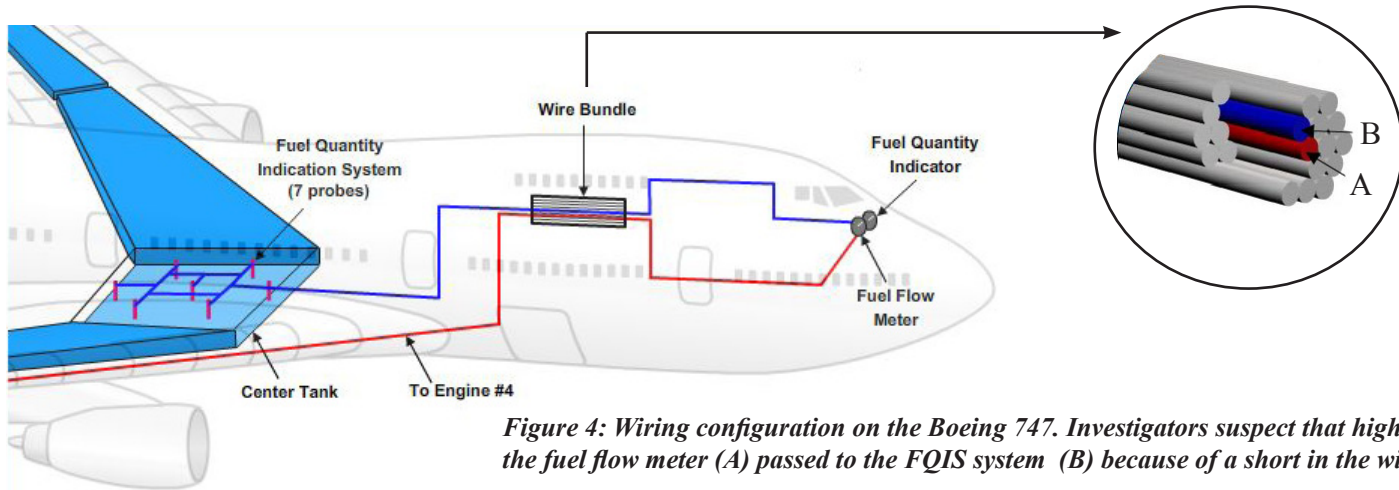
The minimum ignition energy for hydrocarbon fuels is 0.25 millijoules (mJ). To keep the vapor in the tank from igniting, the power supplied to FQIS wiring was intended to have a limit of 0.02 mJ, which would be extremely low when compared to other B-747 systems. The FQIS wiring runs from the fuel tanks to the flight deck along raceways shared with wiring from other systems such as the cockpit voice recorder (CVR), fuel flow meter, and cabin lights. Such circuits carry much higher voltages and energies than allowed in the FQIS. For example, some cabin lights operate at up to 350 VAC at 400 hertz. FQIS wires co-routed with these other wires in large bundles were found tightly bound together, so that a chafe or cut could affect more than one wire (see Figure 4).

Because FQIS wires are the only wires to enter the CWT and because they are co-routed within wire bundles containing circuitry from higher-voltage systems, investigators theorized that a high-voltage circuit contacted FQIS wires due to chafed, frayed, or otherwise damaged conditions. Once this higher voltage passed through FQIS wires to the FQIS probes inside the CWT, a latent fault on the probes, such as silver sulfide deposits, may have caused an electrical arc and subsequent tank explosion.

**Figure 4: Wiring configuration on the Boeing 747. Investigators suspect that high voltage from the fuel flow meter (A) passed to the FQIS system (B) because of a short in the wire bundle.**

wire. The same wire routes were then found to contain other potential electrical energy sources, such as the cabin lights that had been beneath the cockpit. The cabin lights had required maintenance on multiple occasions in the month before the accident. Any of these potential sources could have passed excessive energy to the FQIS system within the CWT (See Figure 4).

ers, such as those used on TWA 800, do not function fast enough to reliably prevent excessive energy from entering FQIS wires, as previously assumed. Later, NTSB recommended installing arc-fault circuit breakers and other current limiting devices, instead of simple thermal-mechanical circuit breakers to prevent energy transfers.
